# FLIGHT-TEST TEMPERATURE DATA FOR AN ALTAIR-IIIC1 ROCKET MOTOR

*by James L. Raper*  
*Langley Research Center*  
*Langley Station, Hampton, Va.*

NATIONAL AERONAUTICS AND SPACE ADMINISTRATION • WASHINGTON, D. C. • AUGUST 1965

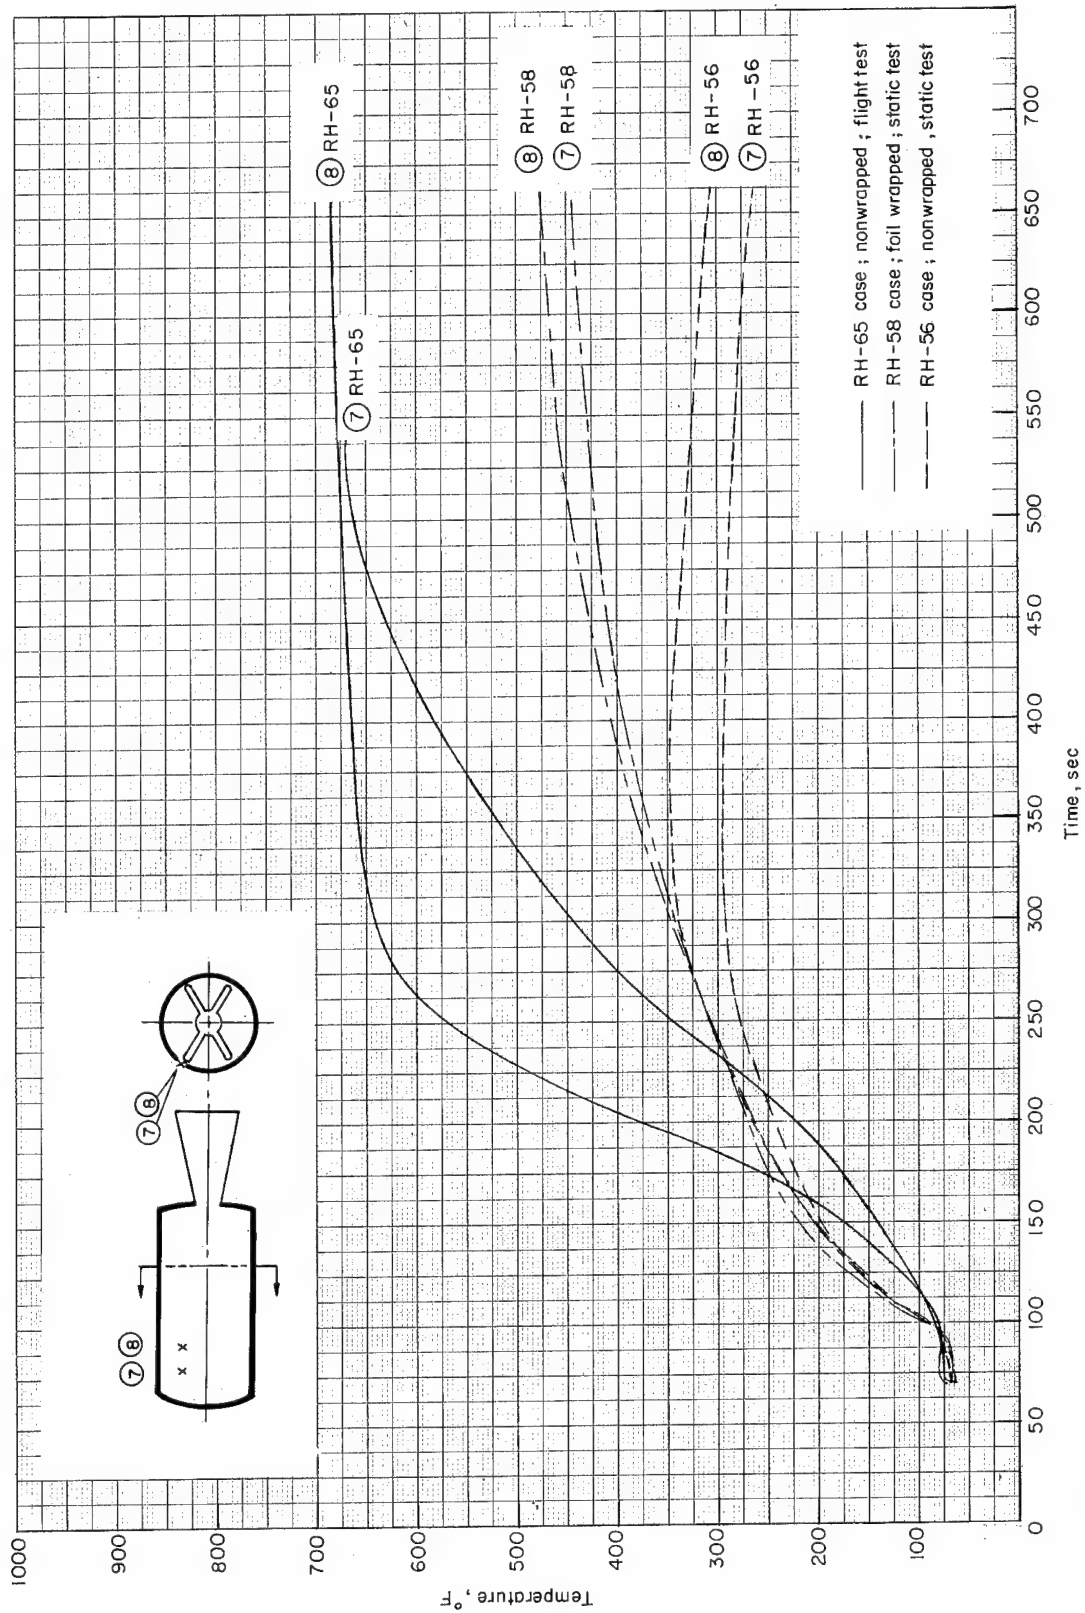
Figure 10.- Forward-cylinder temperatures measured at thermocouples 7 and 8.

Figures 9 to 13 compare the results of the flight test and of the static altitude tests. As indicated in the figures, the flight motor had silver conductive paint on the forward dome but was natural elsewhere. Examination of the data for thermocouple (TC) 4 in figure 11 indicates that the addition of an aluminum-foil wrapping to a natural case can increase the maximum temperature of the case from 400° F to 700° F. It should be noted that for TC 4 the maximum temperature for the foil-wrapped case occurs 150 seconds after that for the nonwrapped case. Similar results were observed during the static test of an Altair-IIIB1 (S/N RH-47) motor tested at 200 rpm as indicated in reference 2. Examination of the Altair-IIIB1 motor after testing showed a large deposit of resin on the aluminum foil. As a consequence of this resin boiloff, the fiber-glass filaments in the chamber midsection were left essentially unbonded. This condition resulted from a case surface temperature of 700° F measured over a grain slot (fig. 4).

Based on the Javelin data, the temperatures measured in flight on the chamber side walls are significantly higher than for the static tests. For the unwrapped motor cases (RH-56 and RH-65), the chamber-wall temperature in the flight test was 400° F greater than in the static tests as shown in figures 10 and 11. Even though the heat shield did not eject as planned, it had no effect on the side-wall temperature histories since there was no indicated temperature increase prior to the time that the heat shield did eject. A possible reason for this difference between flight- and static-test data at simulated altitude is in the test environments. The static tests are generally performed at a simulated altitude of about 100,000 feet while the flight test of the Javelin vehicle extended up to  $2.4 \times 10^6$  feet as shown in figure 3. The considerably lower density of the flight environment reduces the case heat transfer to the surrounding atmosphere compared with the transfer which occurs in the AEDC tunnel tests. In figure 14 temperature for the forward dome of Scout S-122 is compared with the temperature on the Javelin and AEDC motor tests. An Altair-IIIB1 (RH-61) was used on Scout S-122, but dome temperatures would be the same as those from Altair-IIIC1 motors since dome insulation is identical. The Scout S-122 motor had an aluminum-foil blanket over the forward dome and was spinning at approximately 160 rpm. Each flight test shows larger maximum temperatures - a maximum temperature which occurs much later than in the static tests - and a much lower rate of cooling after maximum temperature.

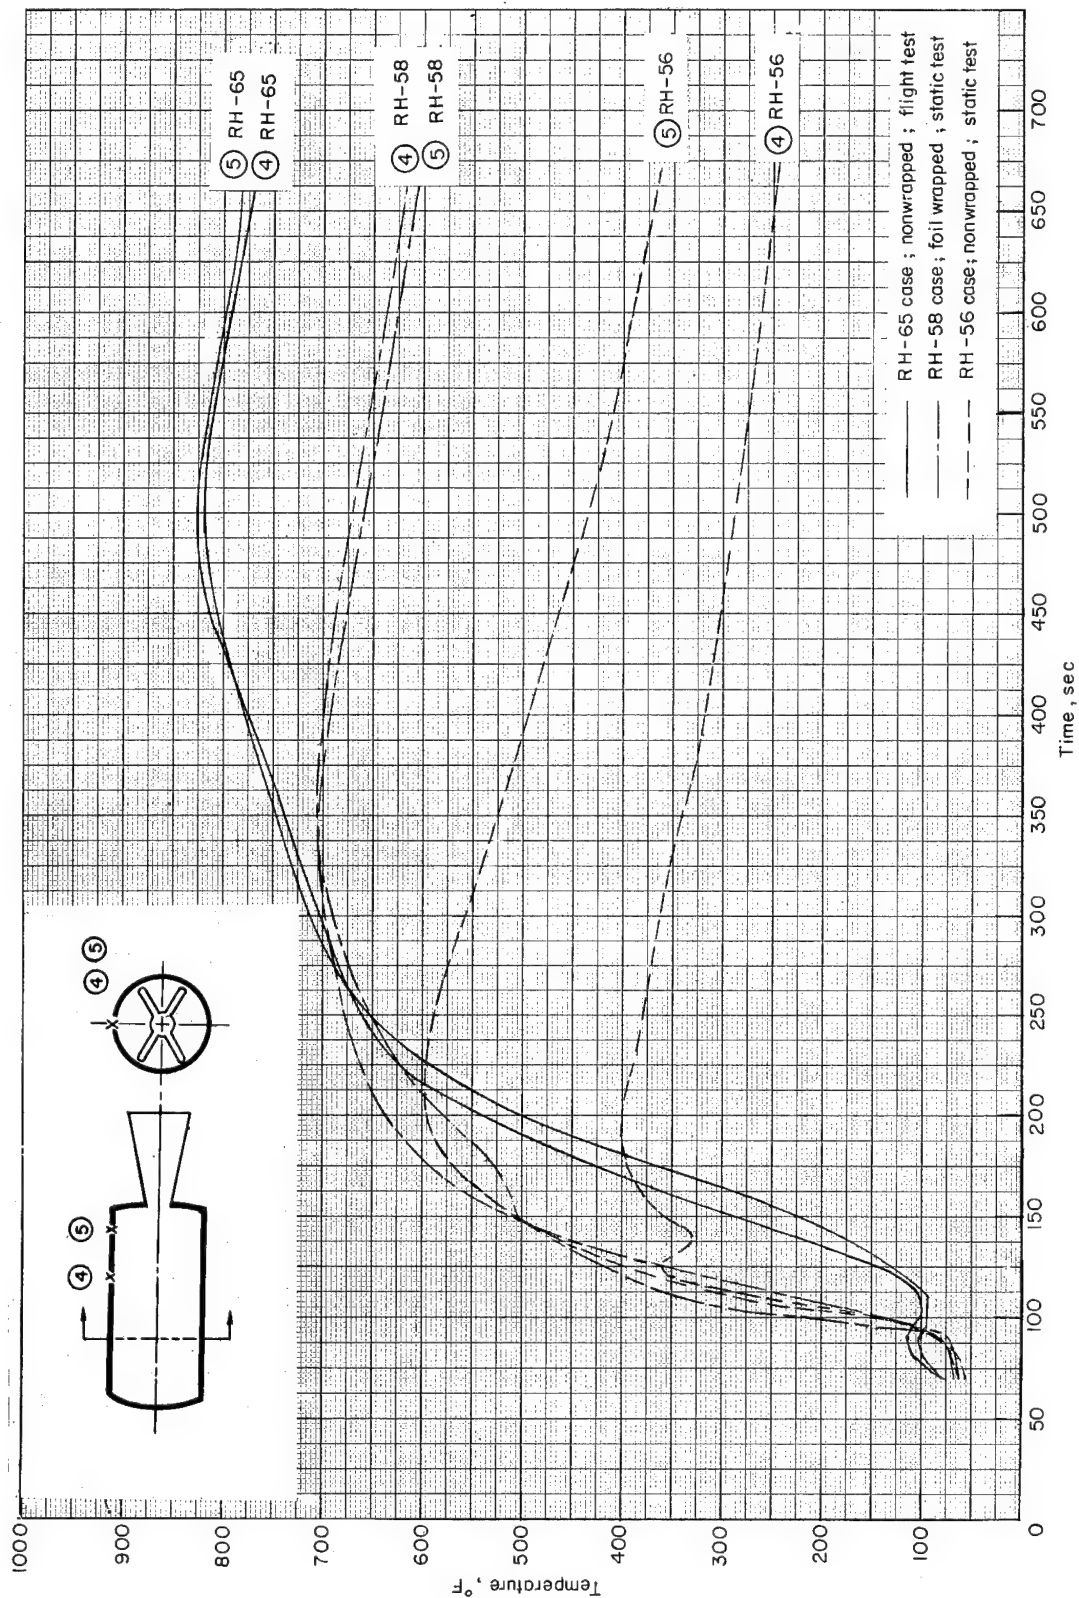
Figure 11.- After-cylinder temperatures measured at thermocouples 4 and 5.

and resin boiloff. A motor case charred to this extent is incapable of transmitting any significant bending or compressive loads. Reference to figure 11 indicates that the motor problems due to temperature become serious about 75 seconds after motor ignition.

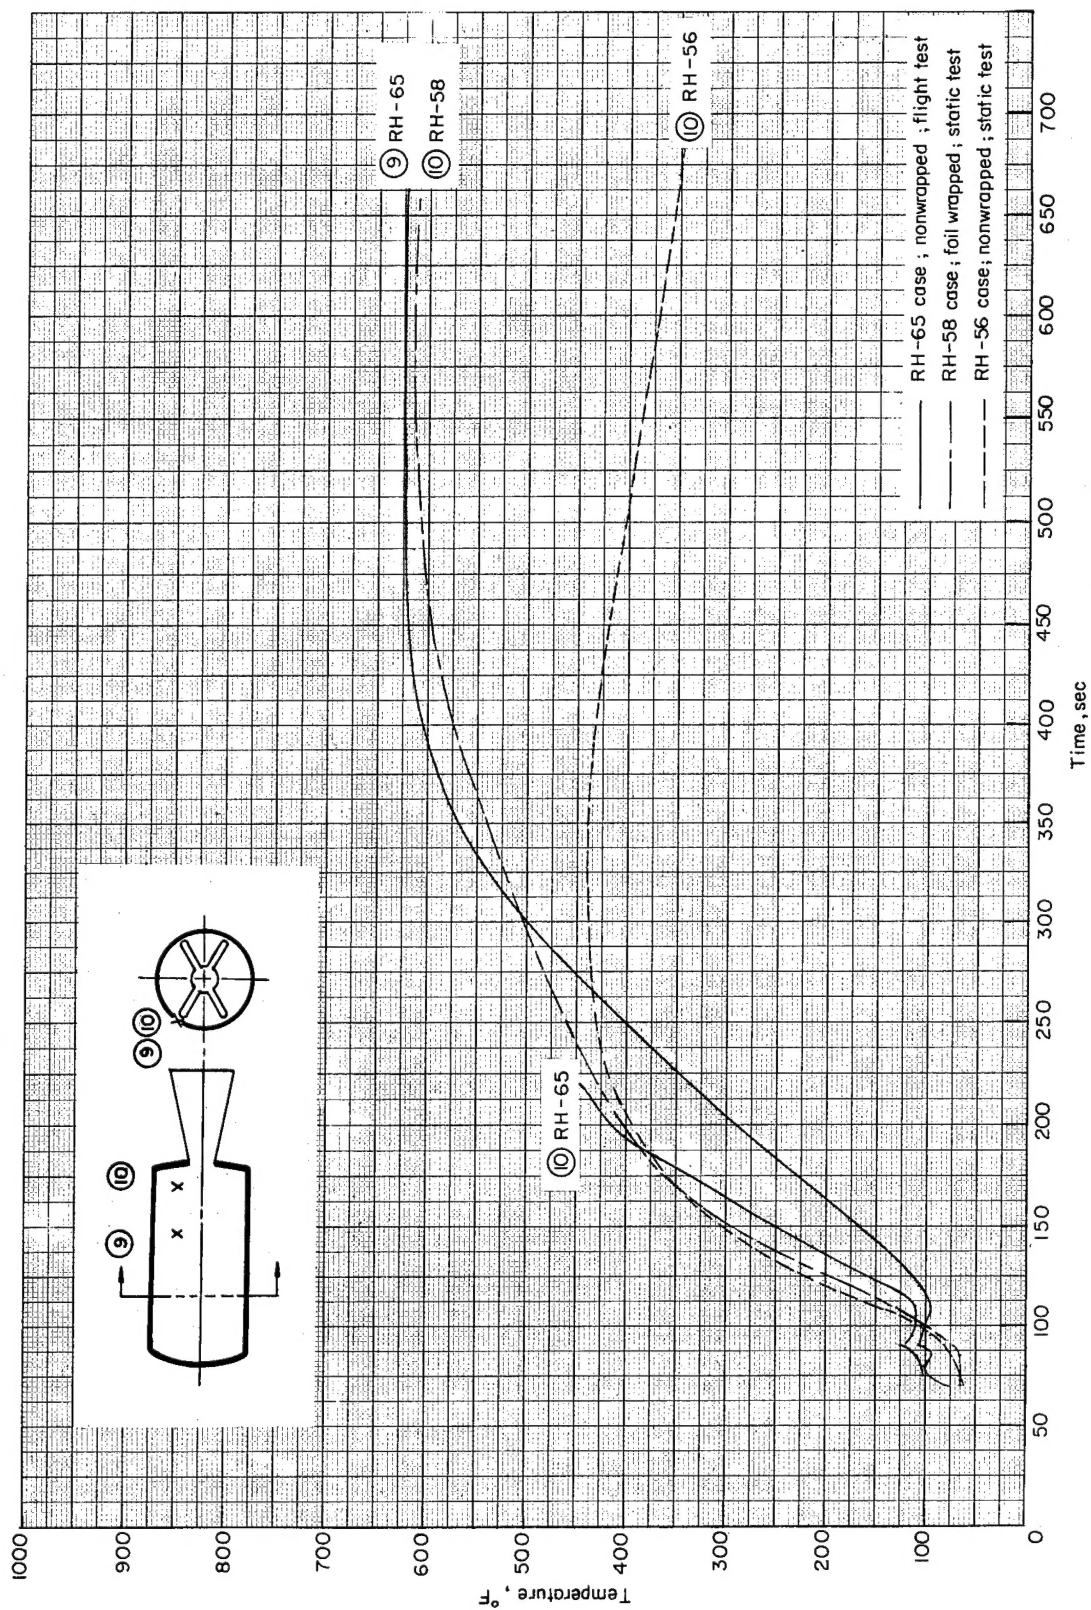
Figure 12.- After-cylinder temperatures measured at thermocouples 9 and 10.

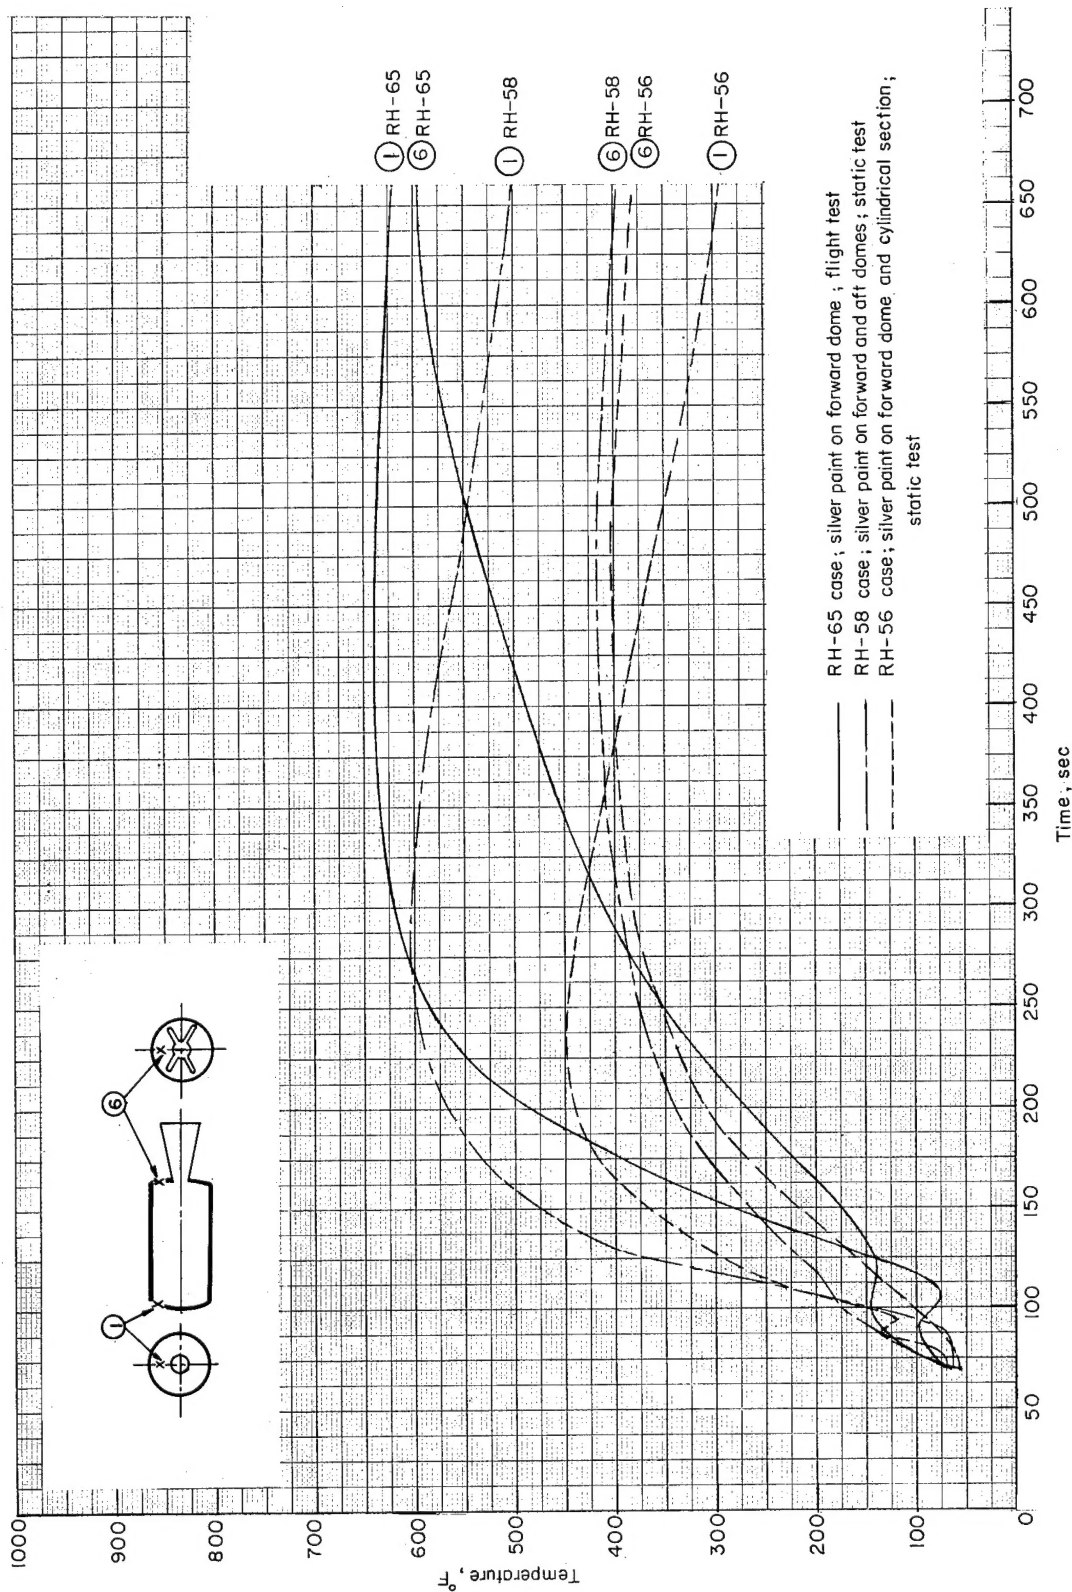
Figure 13.- Forward- and after-dome temperatures measured at thermocouples 1 and 6.

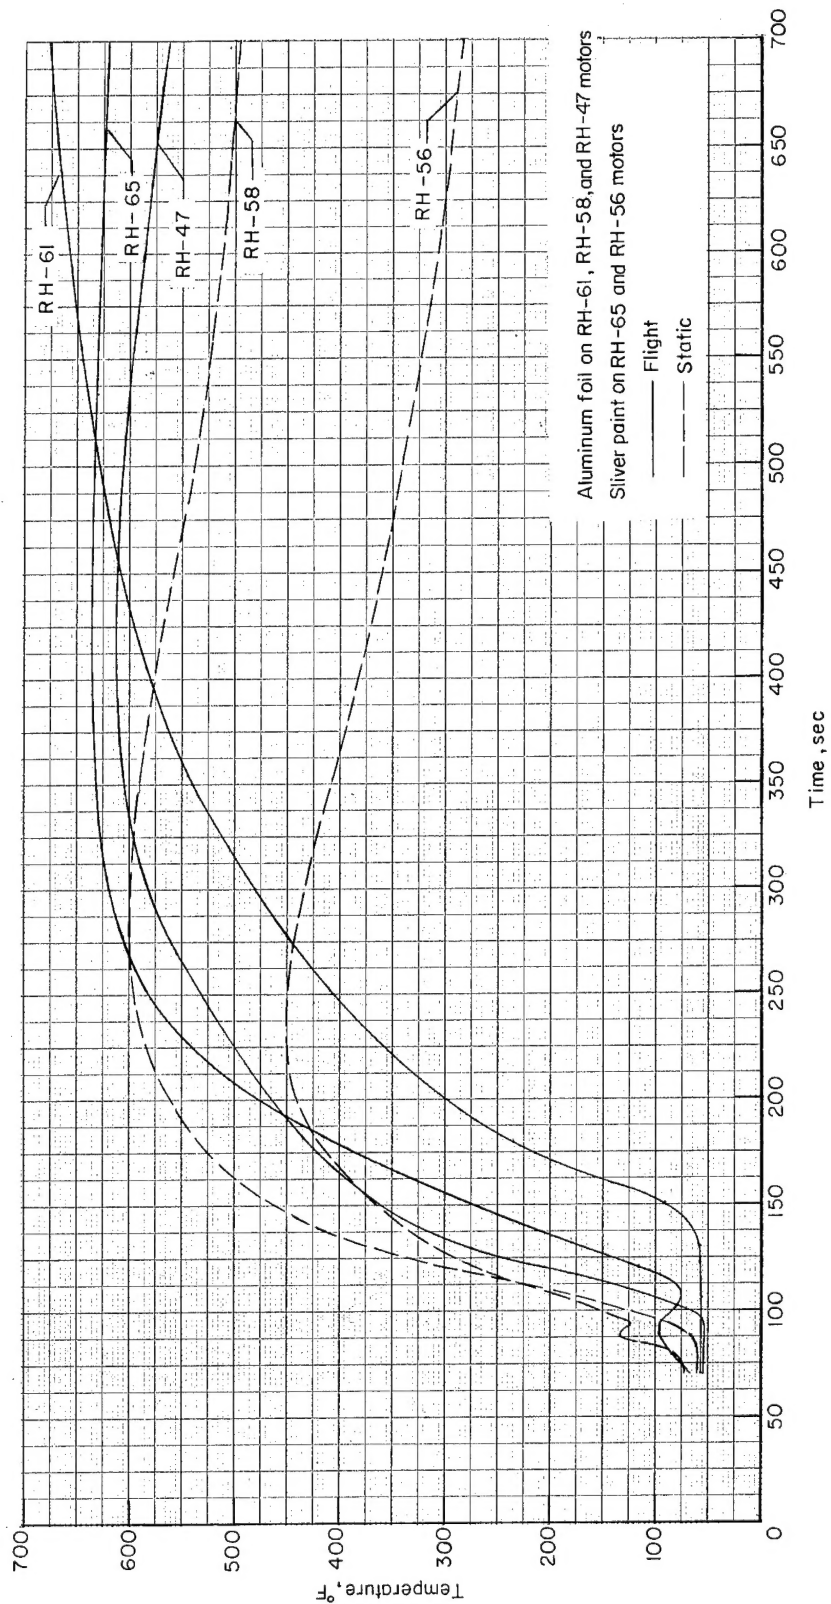
Figure 14.- Comparison of forward-dome temperatures from static and flight tests.
